# Intel® I/O Controller Hub 9 (ICH9) Family

## Specification Update

— *For the Intel® 82801IB ICH9, 82801IR ICH9R, and 82801IH ICH9DH, 82801IO ICH9DO I/O Controller Hubs*

Order Number: 316973-009

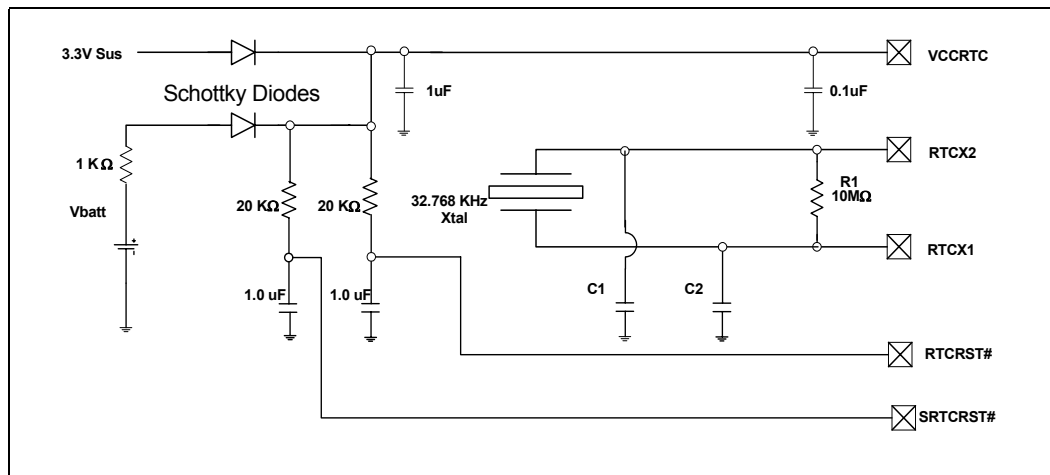
### 3. External RTC Circuit Correction

The following figure replaces Figure 2-2 of the Datasheet.
